Parietal necrosis around a double ileostomy

using eakin **Wound Pouches™** and accessories

Case study submitted by:
Manuela Hagues, Stoma Care Nurse,
Pavillon Derocque - CHU de Rouen, France

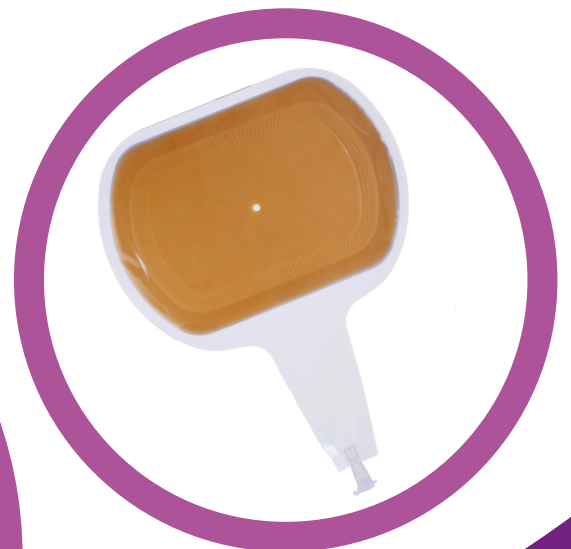
DEBRIDMENT OF NECROSIS

- First review at ICU, she presented with a large necrotic area adjacent to laparostomy scar with abundant flow of digestive output.
- Drainage pouch with large diameter used but struggling with multiple leakages, resulting in damaged periwound skin.
- Commenced debridement of necrotic tissue.
- Changed to an eakin **Wound Pouch™** without window (initially). This stayed in place for 8 days.

and application of eakin **Wound Pouch™**

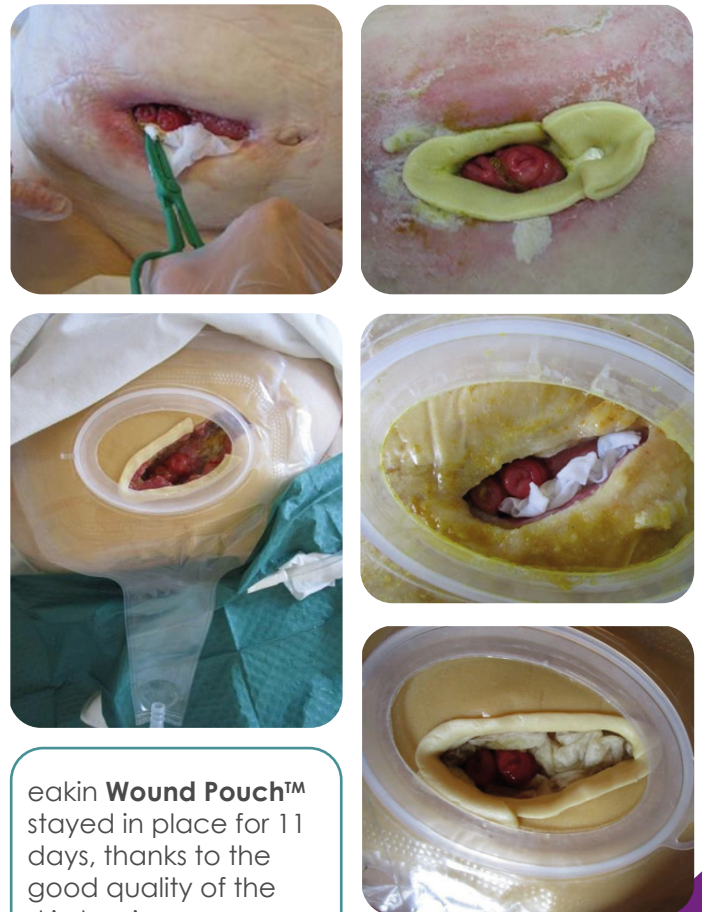
eakin **Wound Pouch™** stayed in place for 11 days, thanks to the good quality of the skin barrier.
